# Pre-purchase Survey of Yacht 'Dxxxxx' – 1991 Moody 376

Report number 021401

07/02/2014

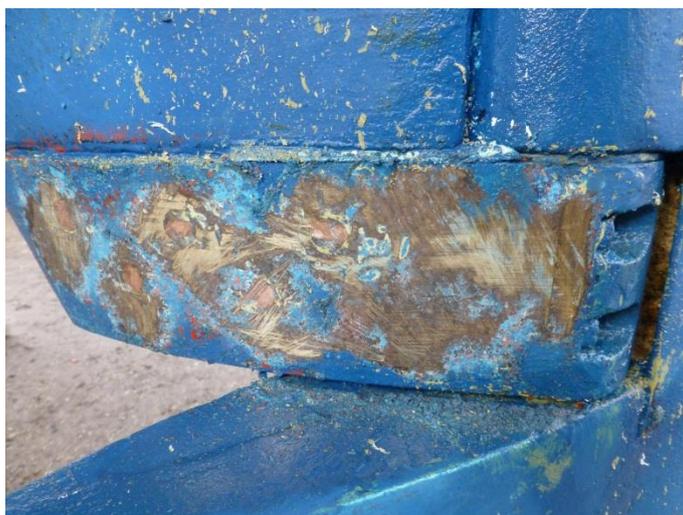
The rudder stock is secured to a bronze fitting at the foot of the skeg. This is fastened to the skeg with five bronze rivets staggered into two rows running from one side to the other.

The heel of the fitting has two half round parts, one forming the aft end of the main part of the fitting and the other is a half round part that is clamped around the rudder stock and fastened onto the main fitting with four bronze machine screws. This forms a bush in which the rudder stock can turn. No slack was detected here. The fitting was sound to the hammer, rivets and fittings showed no indications of corrosion or other defects. The four bronze machine screw fastenings on the half-round section were not tested and, given their key role in the steering system and the planned use of this vessel, they should be drawn for inspection.

**Rudder fittings and cable (Level B)** – Draw bronze machine screw fastenings on half round section of skeg foot fitting, inspect and replace or renew. Replace seal at top of rudder stock. Take up slack in cables. Replace corroded cable grips and fit the correct way round.

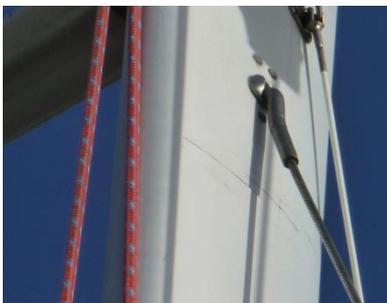
There was what appeared from a photograph to be a series of scratches to mast anodising below the top spreads on port side. This needs inspecting when aloft or with the mast unstepped.

**Spars (Level B)** – Replace all cotter rings with split pins. Open split pin at kicker rod foot. From aloft or with mast unstepped, inspect spreaders for damage to the leading edges, mast condition and fittings.

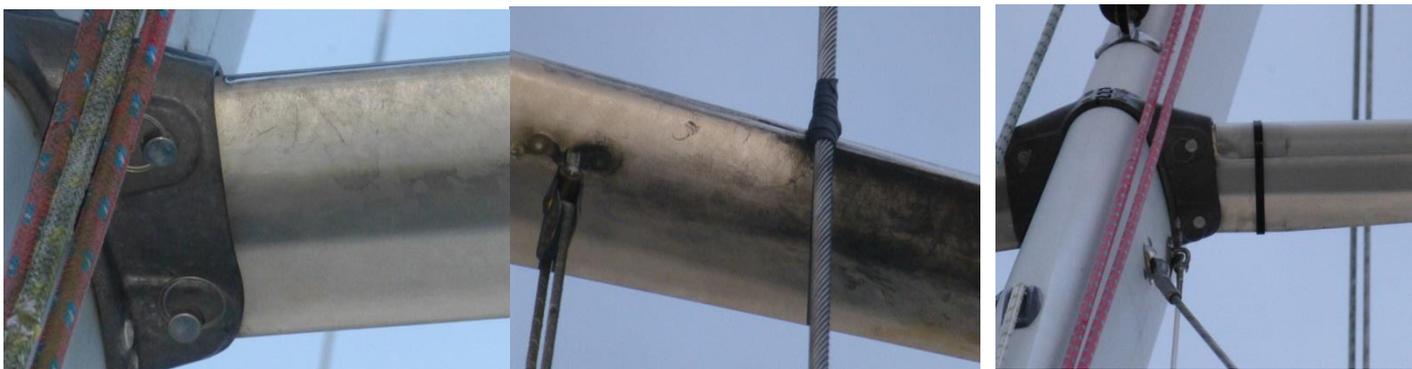
Halyards had been rubbing on the spreaders and there may be damage to the spreaders. The leading edge of the port side top spreader is protected and that may conceal damage. The upper spread root fitting was not flush with the mast on the port side. These should be inspected aloft or with the mast unstepped.
