Full condition Survey of Yacht 'XXXXXX' – 1932 Cardnell Bros Yawl

Report number 041401

18/04/2014

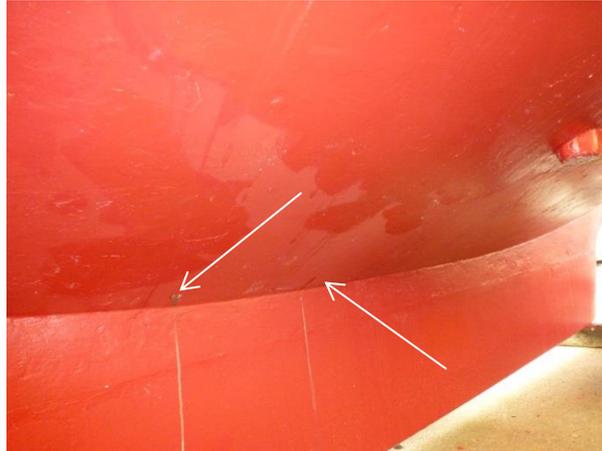
The planking was hammer sounded externally and internally and random spiked internally and was found sound. The planking in the immediate vicinity (within one inch approx) of two screw fastenings on the starboard garboard strake

was seen to have been degraded by electro chemical decay (ECD) which can occur around noble fastenings and fittings and to which Honduran mahogany has relatively poor resistance.

Figure A-1 Electro chemical decay around garboard fastenings allowing bilge water to weep out past fastenings

Recommendation (Level A) – All garboard fastenings and a sample of plank to ‘floor’ fastenings should first be exposed, the surrounding timber examined and fastenings tightened (to check their holding in the hog). Where there is evidence of ECD, fastenings should be drawn for inspection and renewed if necessary. Where timber is degraded (eg those identified in Figure A1) fit graving pieces of half the thickness of the outer plank plus adequate stopping to minimise corrosion. Use of water based-epoxy as a primer will allow a strong repair even when the plank is still too wet for conventional epoxy.

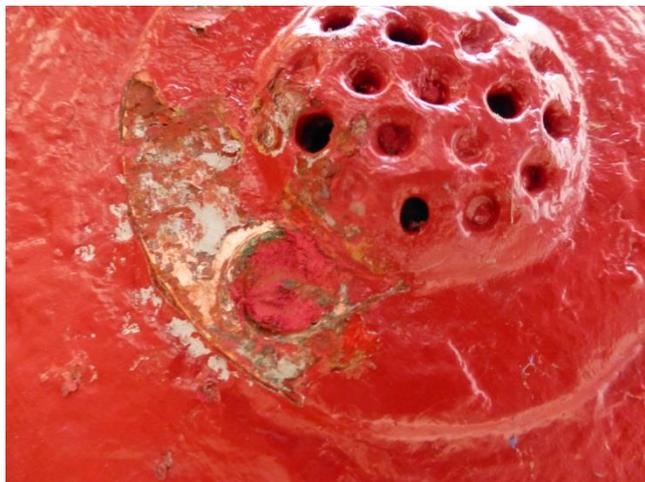
Given the corroded bronze fastening on the heads inlet (see B4 below), stray AC or DC current is suspected as well as the effects of the anodes.

10. Heads inlet – To starboard of the heads and below the static waterline. The skin fitting, seacock and tailpipe, believed bronze were in serviceable condition, secure to the hull when vigorously tested, opened and closed fully though stiff. Hose clips loose and corroded. Hose serviceable. Bronze fastenings externally were badly corroded with red copper oxide indicating electrolytic or galvanic activity. This is either related to the anode (though out of the line of sight and some distance from them) or stray current from this vessel, the adjacent vessel(s) or underwater cable. The fastenings should be replaced.

Figure B-1 Heads inlet fastening corroded

Recommendation (Level A) – Replace aft cabin sink outlet gate valve with bronze or DZR ball valve and replace hose to this valve with a longer length of flexible hose and check skin fitting internally before re-using. Free log paddlewheel. Free-up the engine inlet ball valve. When water tank is removed replace gas locker drain skin fitting with larger diameter (see gas installation G2). Service all three forward seacocks (WC and galley sink). Fit handle and new flexible hose to galley sink outlet. Fit double clips to all below waterline tailpipes. Renew bronze fastenings in heads inlet, renew heads inlet and outlet clips. See also B.3. Wooden bungs should be located and secured with a line close to each through-hull fitting, including transducers. Check for stray current when afloat.
